Tracing mine accidents with satellite data

April 13, 2023 | Isabel Plana

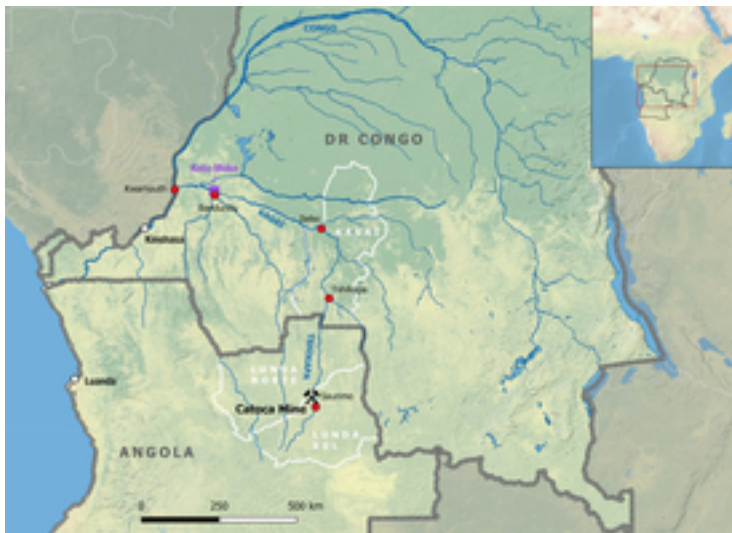
The spill of toxic mine wastewater at the Catoca mine affected not only northern Angola, but also the neighbouring country of the Democratic Republic of Congo. Over a length of 1400 kilometres in all, an entire river system was polluted. The pollution extended from the Tshikapa River over the Kasai to the Congo – with disastrous consequences for the environment and the health of the population.
 (Graphic: Désirée Ruppen)

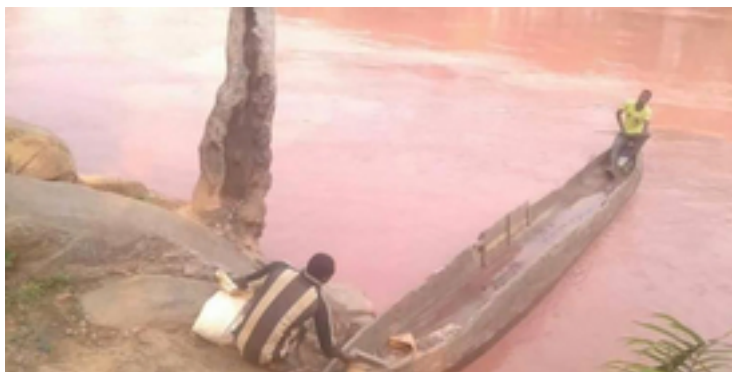
In early August 2021, pollution reached the Kasai River in the Democratic Republic of Congo and turned the water orange-red.
 (Photo: Frank Stany)
