# **Evaluating the ecological benefits of restoration** measures

November 3, 2016 | Andres Jordi Topics: Biodiversity | Ecosystems

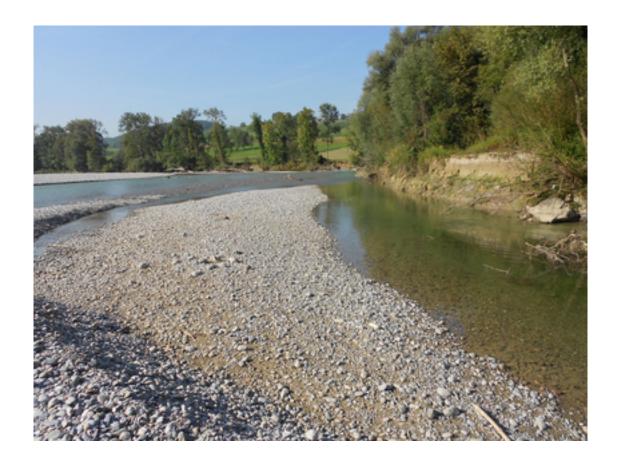
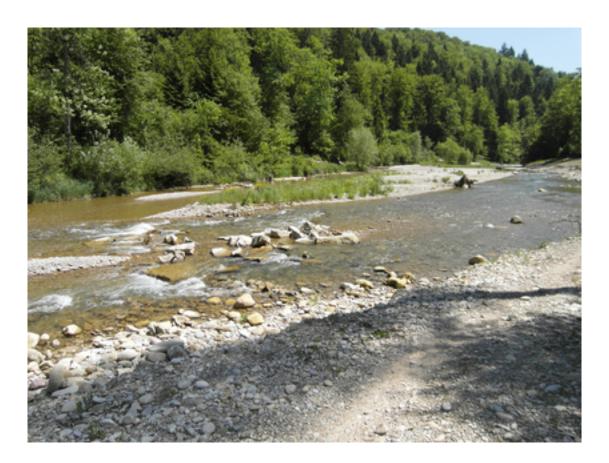
Fig. 2: Restored reaches of the Thur (left) and Töss (right). Photos: Amael Paillex, Peter Reichert

To test how the method works in practice, Paillex and his co-workers investigated restored and unrestored sites on the Thur and Töss. Both of these rivers were channelized in the mid?19th century in order to protect against flooding and to gain agricultural land, and they have both been partly restored in recent decades (Fig. 2). The researchers studied a 1.5?kilometre reach of the Thur restored by the Cantons of Thurgau and Zurich in 2002 and a 200-metre stretch of the Töss restored in 1999 by the Canton of Zurich. The restored reaches were compared with corresponding degraded reaches. Paillex reports: "Our analyses show an improvement in the overall ecological state of the restored reaches, both on the Thur and on the Töss." While the unrestored reaches of both rivers are rated as poor, the restored reaches are assessed as moderate in the case of the Thur and (barely) good in that of the Töss (Fig. 3).

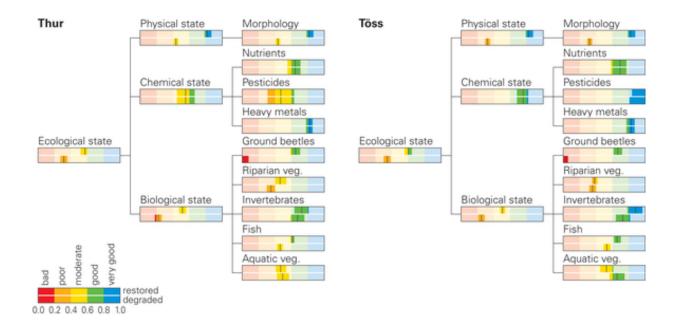
Fig. 3: Evaluation of the ecological state of restored and unrestored reaches of the Thur and Töss rivers. The vertical black lines indicate the median quality values; uncertainty is represented by the coloured areas. The colour-coded quality classes are derived from the Swiss river assessment procedure and are similar to those established for the EU Water Framework Directive.

By contrast, the quality values for riparian vegetation (Thur: 0.47; Töss: 0.39) show less marked improvements. Here, the restored reaches are classified, respectively, as moderate and poor (Fig. 3). According to the researchers, this could be due to the spread of non?floodplain species from nearby agricultural land, impairing the character of the alluvial habitat. The return of more typical vegetation is also impeded by a lack of connectivity with other floodplains. This may also partly explain why aquatic vegetation failed to benefit from restoration: in the Thur, indigenous species had to contend with an invasive plant species, and in the Töss the number of species declined.

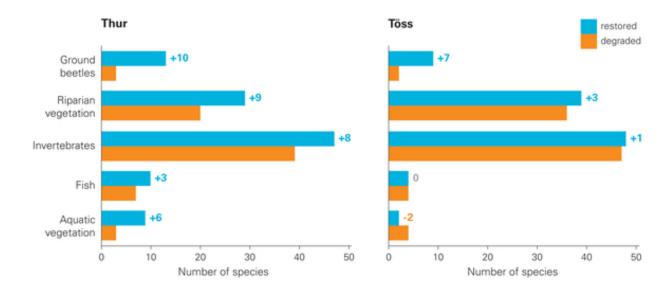
Fig. 4: Differences in diversity between restored and unrestored reaches. As the quality values for riparian vegetation show (cf. Fig. 3), an increase in the number of species does not automatically represent an ecological benefit.

restored (widened) reach shows greater variability in river width, water depth and flow velocity than the unrestored reach. The riparian zones are wider, with higher habitat diversity. In most cases, species diversity also benefited from the enhancement (Fig. 4): for example, 13 ground beetle species are now found at the restored Thur site, compared to only 3 at the degraded site – an increase in the quality value from 0.04 (bad) to 0.67 (good). On the Töss, the number of ground beetle species rose from 2 to 9 (improvement in quality value: 0.03 to 0.69).
